Mapping current slope failures on the western slope of the Heringeš massive in Košice.

Michal Gallay

Institute of Geography, Faculty of Natural Sciences, michal.gallay@upjs.sk Pavol Jozef Šafárik University in Košice, Slovakia

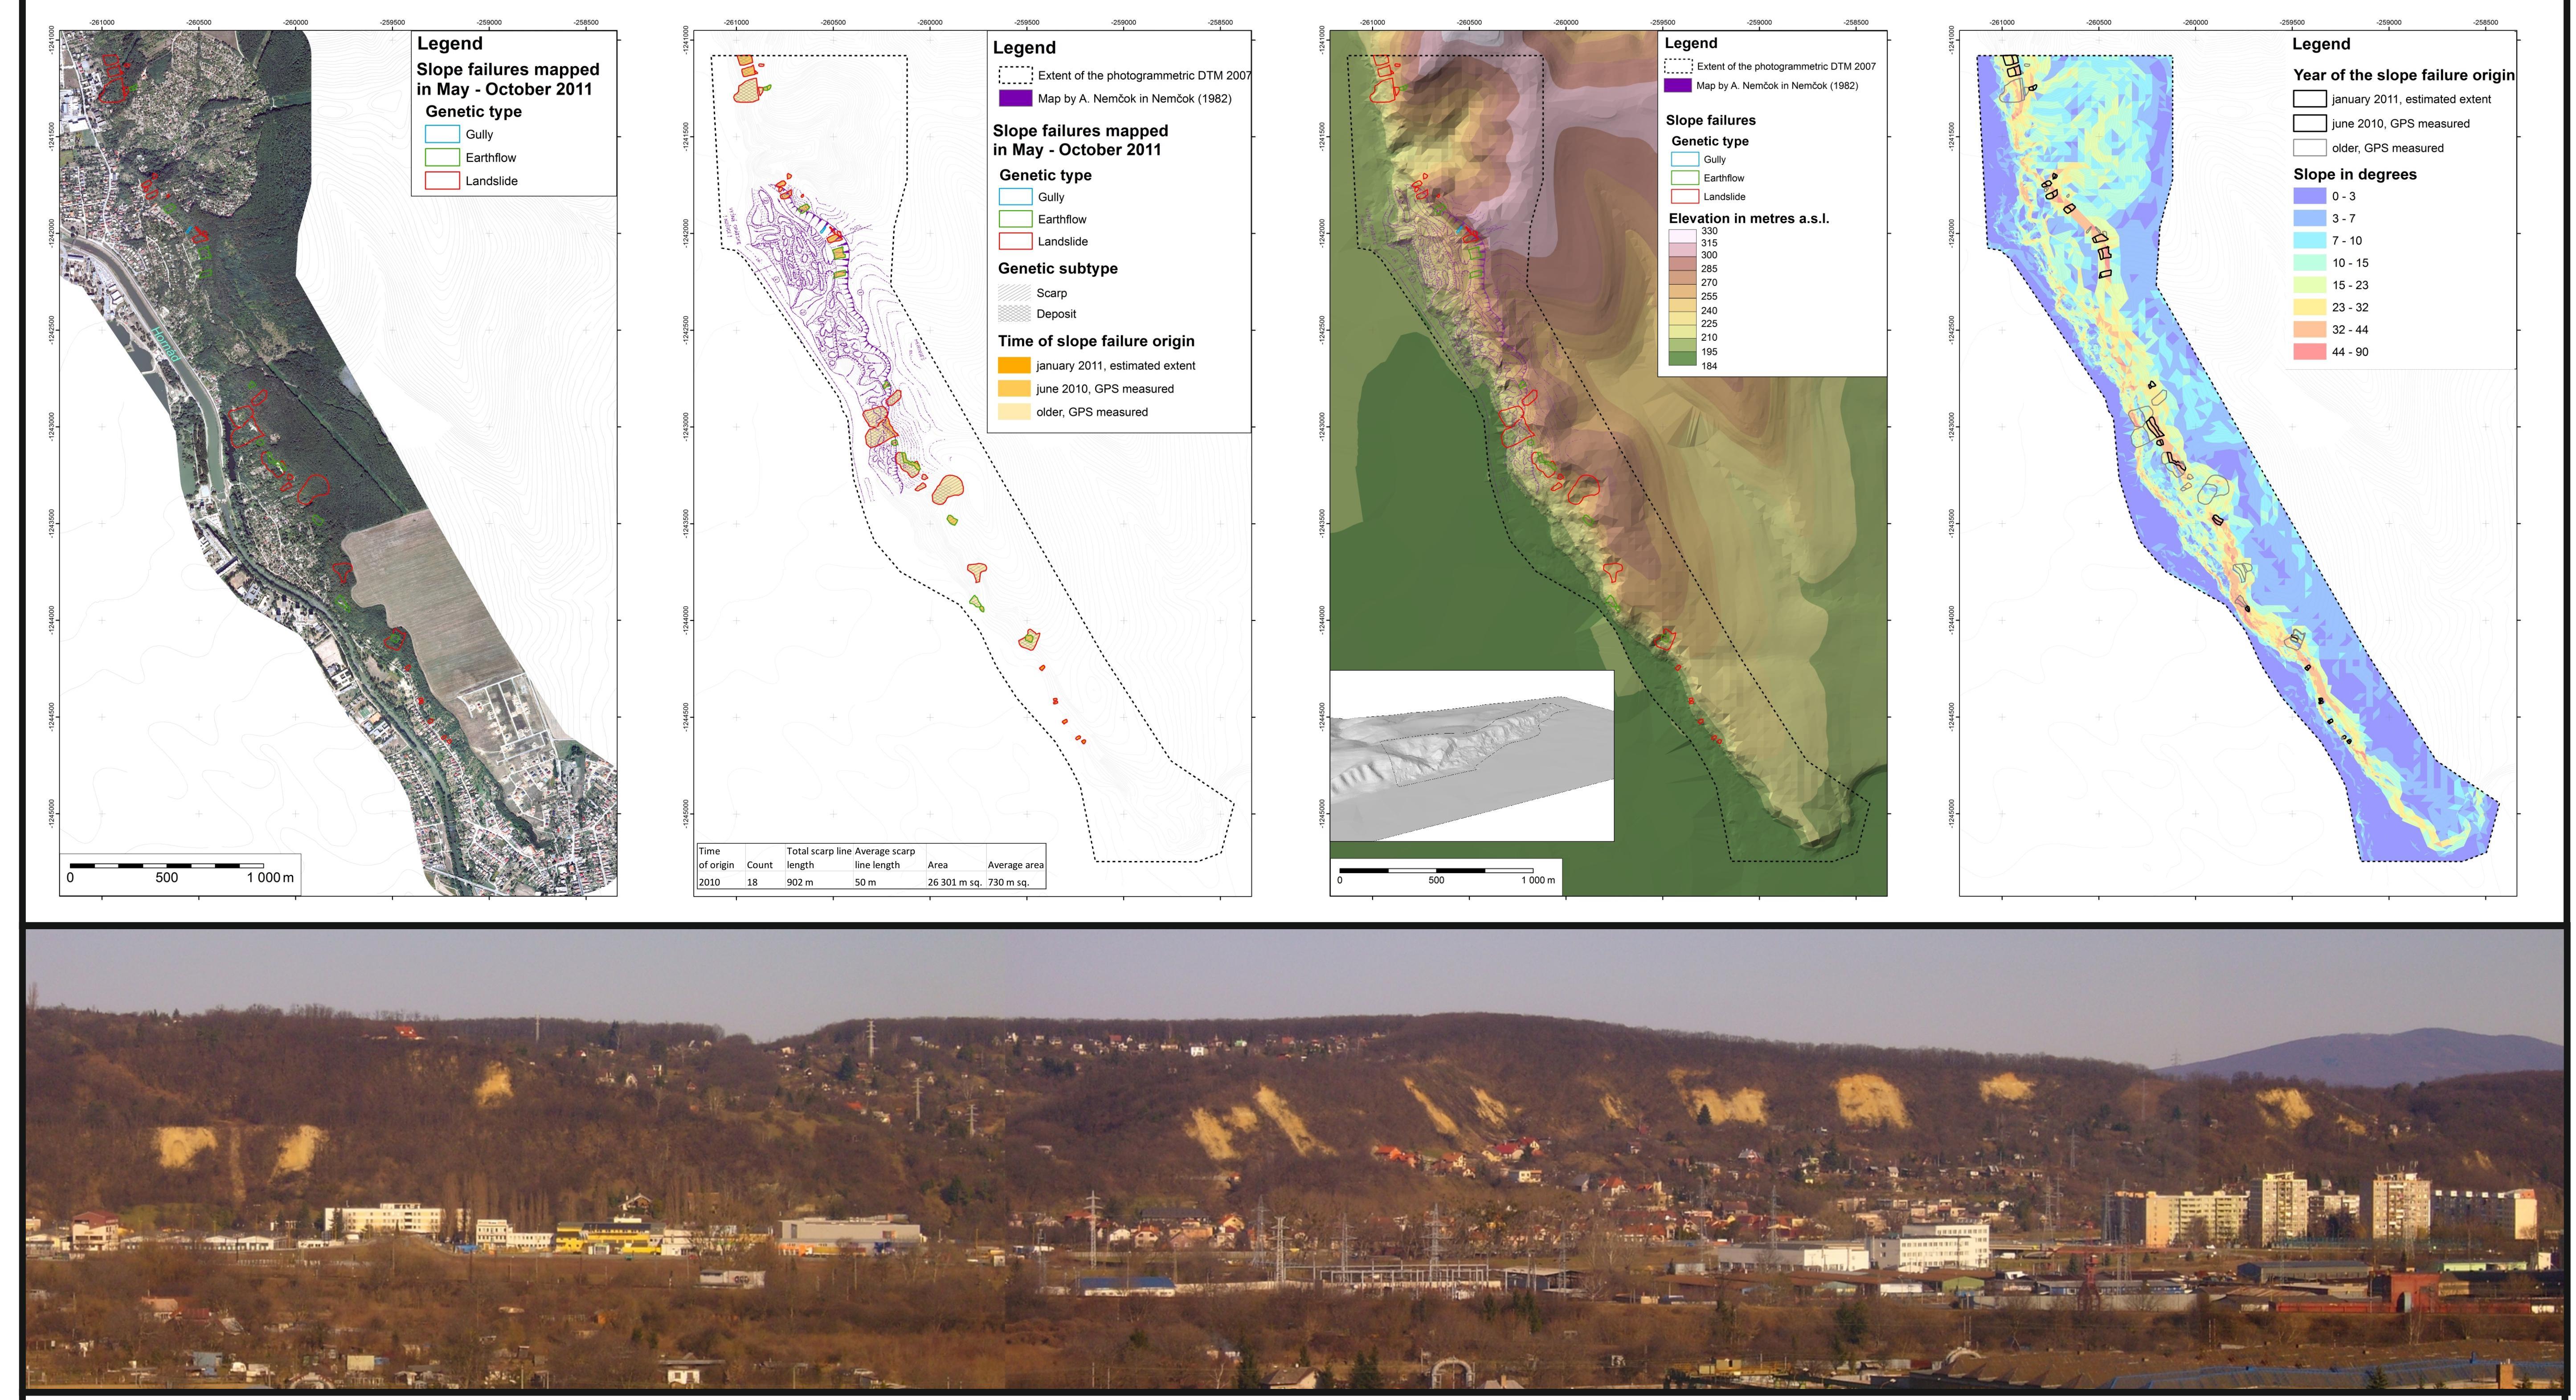
This research presents results of the first stage of mapping of the most recent failures which occurred after abnormal rainfall in the spring of 2010. Digital geomorphometric analysis shows that the earthflows and shallow landslides of the 2010 occurred on the most inclined slopes. Although, there have been no sudden movements recorded since the last sliding in 2010, such processes can occur on similar sites which have remained unaffected so far. Further, marked cracks of soil layer were found above scarp lines of 2010 on the slopes behind the houses on the Dubová street, in particular. Immediate rapid sliding if soil moisture increases can be expected in on such places.

Real time differential GPS (EGNOS corrections, average vertical precision +-2 metres) was used to record the scarp lines of the recent und older failures. The results are compared with a detailed digital terrain model derived from photogrammetric points (average accuracy below 1 metre, data currency 2007). Another DTM was derived from digitized contour lines of 1:10 000 topographic map. The DTMs were used for geomorphometric analysis.
